Project Number: 45306-1

Subject: Axial Compression Load Tests on Timber Piles with J-COM GFRP Jacket by Comtech Manufacturing and Silprogrout UWR™

AXIAL COMPRESSION LOAD TEST ON TIMBER PILES WITH J-COM -
COMTECH GFRP JACKETS

L18-0566

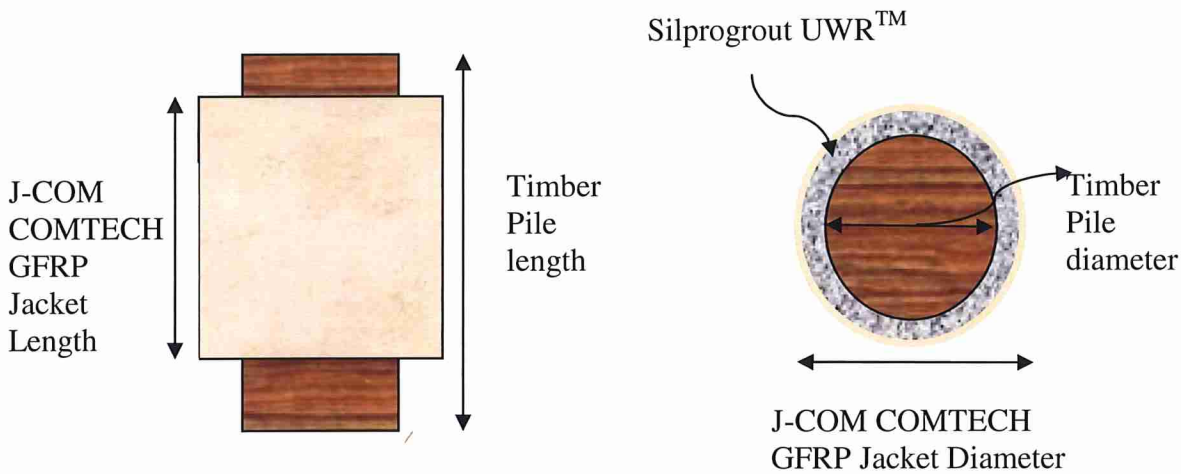
FIGURE NO.1. SAMPLE DESCRIPTION

Samples consisted of timber piles repaired with the J-Com's GFRP Pile Jackets filled with a cementitious grout named Silprogrout UWR™, The samples were reportedly made on February 28, 2018 . Sample number one labeled BOT 3 measured approximately 3-ft- 5-in in length (timber pile) with a diameter of 1ft-3-in and the Jacket measured approximately 2 ft- 11-in in length and 1ft- 4.25-in in diameter; Sample No. 2 labeled MID 2 measured approximately 3-ft- 5-in in length (timber pile) with a diameter of 1ft-3.5-in and the Jacket measured approximately 3ft- 2-in in length and 1-ft- 5-in in diameter; Sample No. 3 labeled TOP1 measured approximately 2ft- 8.5-in in length (timber pile) with a diameter of 1ft-2.5-in and the Jacket measured approximately 2ft- 8.5-in in length and 1-ft- 4-in in diameter; and last sample No. 4 consisted only of a timber pile for control purposes measuring 2-ft long and 1-ft

and 3-in in diameter. Reportedly samples No. 2 and 3 had 40% and 31%, respectively, of their cross sectional area removed to replicate a damage pile. See Figure No.1 below, Pictures on Appendix A , Product Information on Appendix C , and drawing provided by client on Appendix D for clarification.

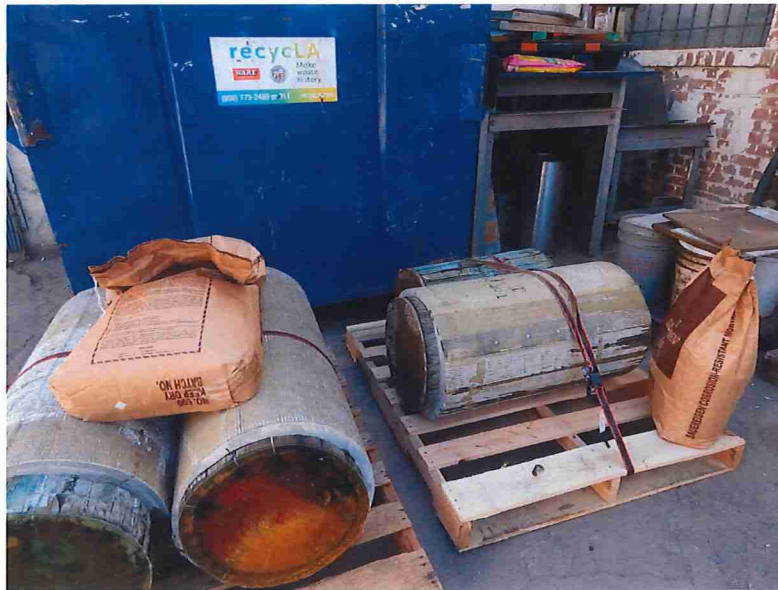
PHOTO No.1 SAMPLES AS RECEIVED

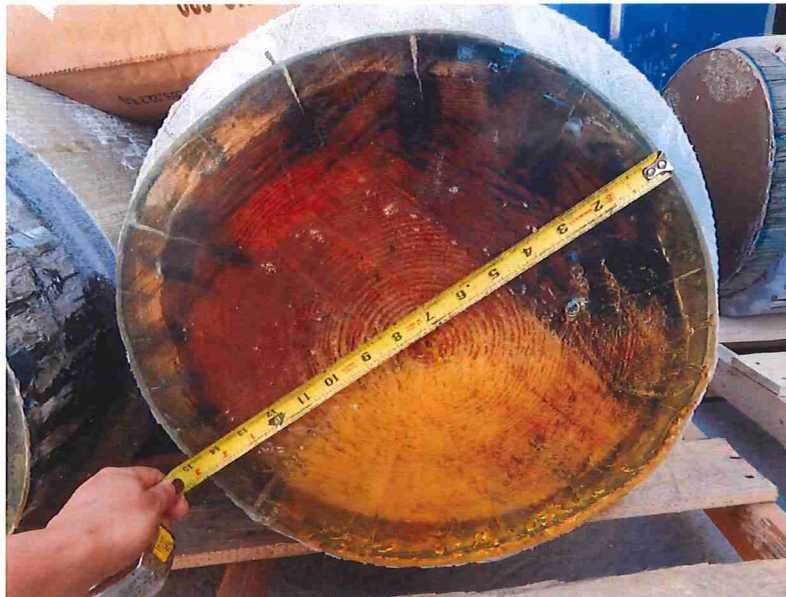
PHOTO No.2 TYPICAL CROSS SECTION OF THE SAMPLES

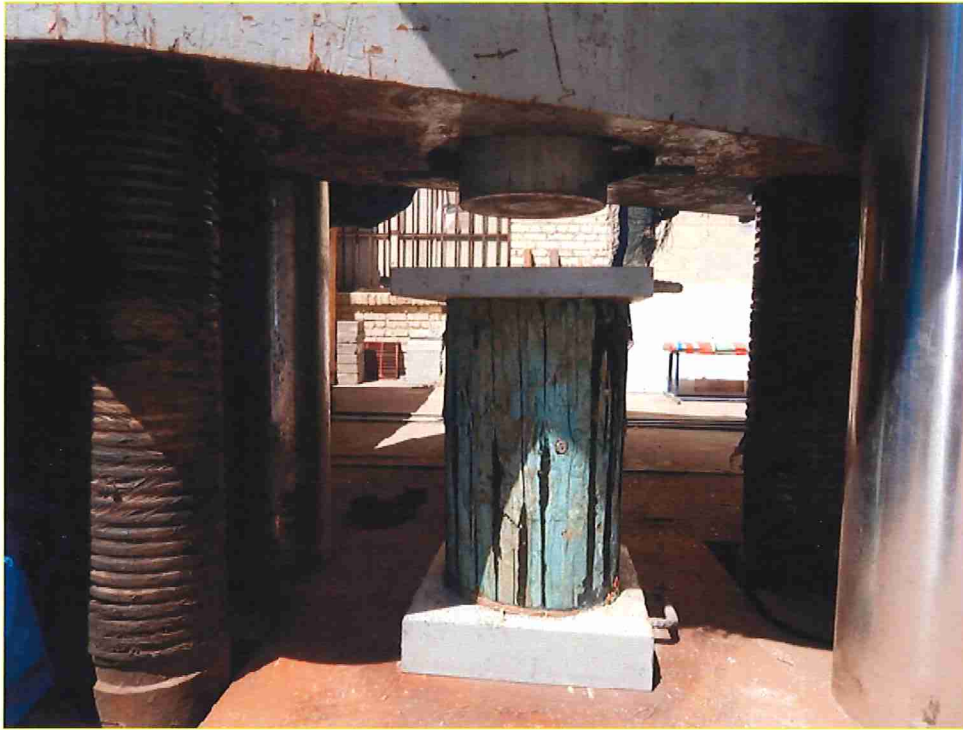
PHOTO No.3 TEST SET UP

The specimens were subjected to axial Compression load test per clients request using a Calibrated Baldwin UTM with 1,000,000 lbs load capacity. The samples were loaded at the center of each pile with using a steel plate with a concentrated vertical load ranging from 500 to 800 lbs. per second until failure occurred or until the sample could not take any more load. Results are included in Section 3.1. and photos are included in Appendix A.

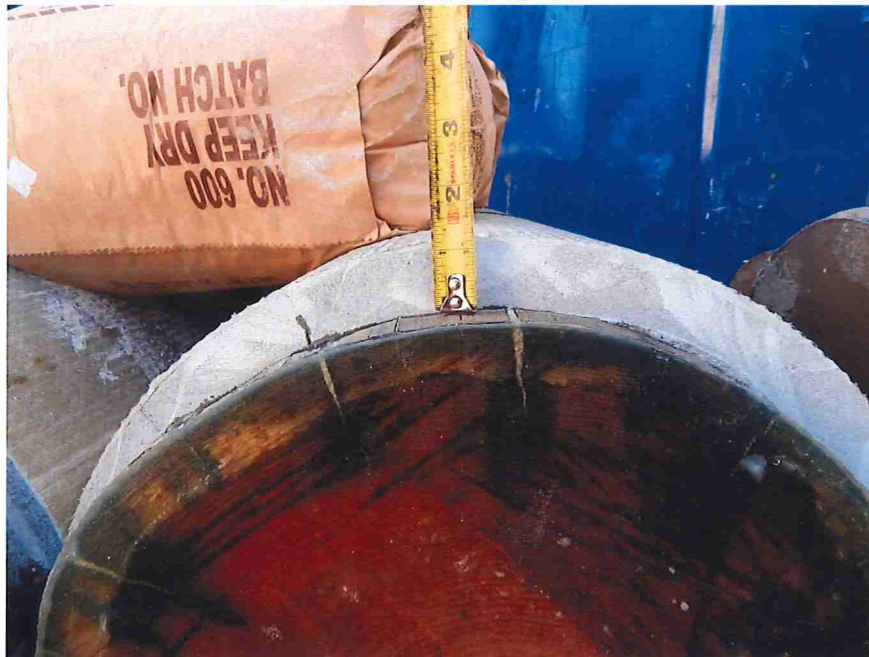
PHOTO No.4 SILPROGROUT UWR™ AROUND THE PILE

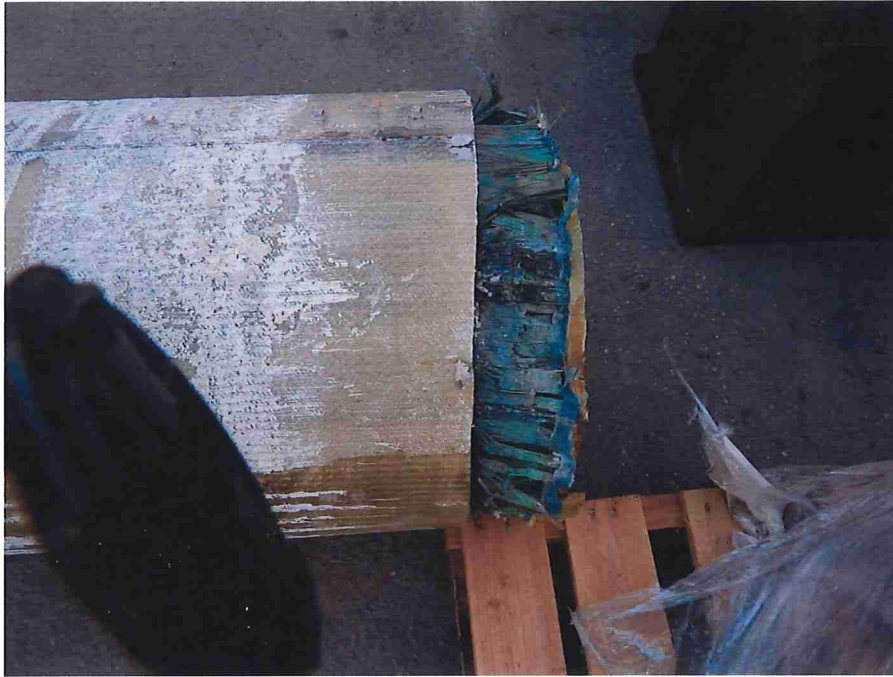
PHOTO NO.5 SAMPLE BOT3 AFTER TESTING

Test No	Test ID	Maximun Load (lbs)	Observations
1	BOT 3	565,400	Timber Pile failed at the bottom.
2	MID2	664,250	Tmber Pile failed at the top
3	TOP 1	692,050	Timber Pile failed at the bottom.
4	No ID	654,350	Sample without GFRP Jacket

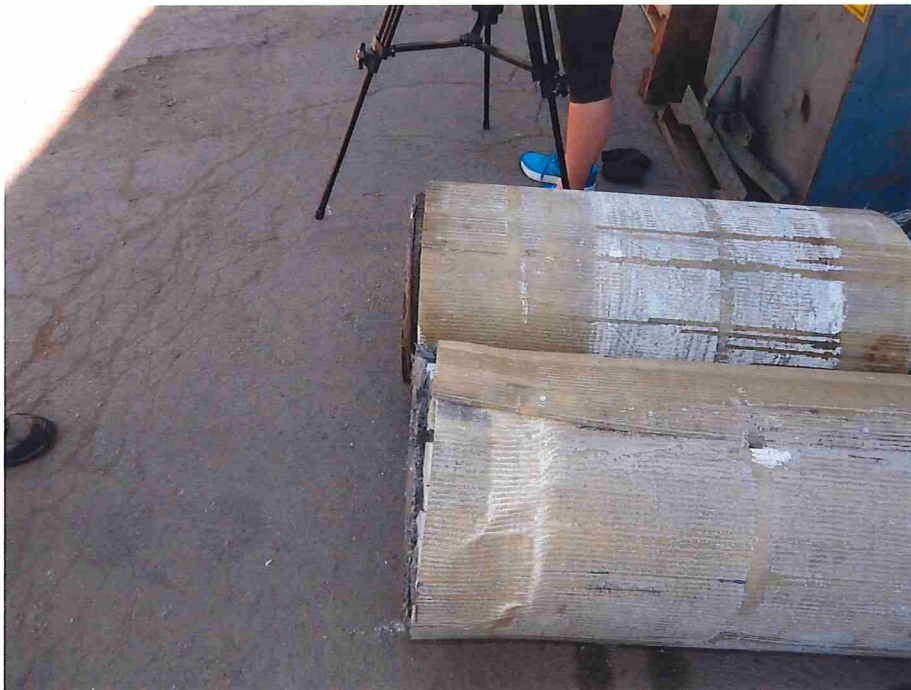
PHOTO NO.6 SAMPLES MID 2 AND TOP 1 AFTER TESTING

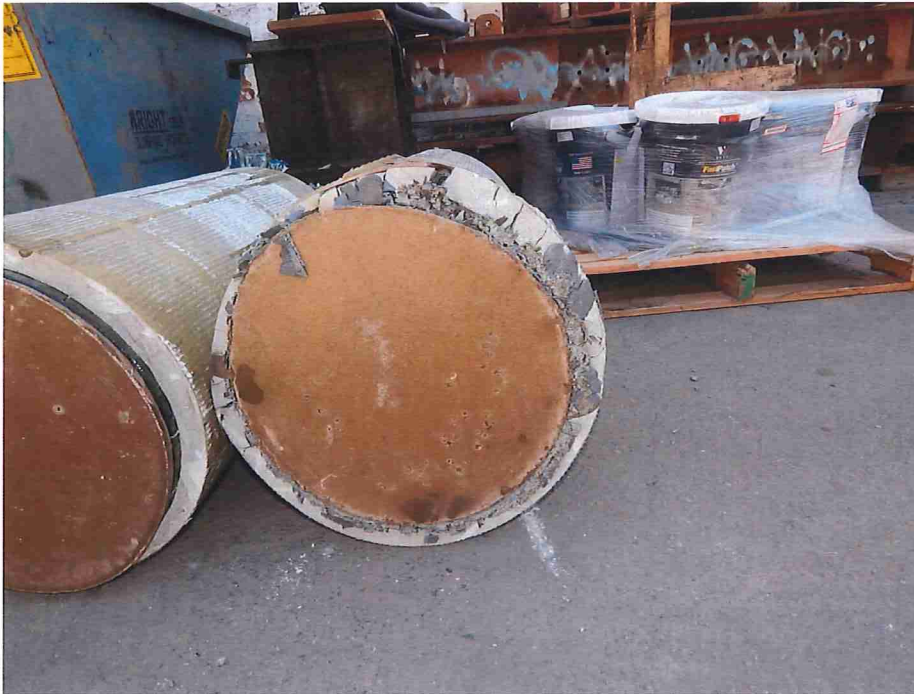
PHOTO No.7 SAMPLES MID 2 AND TOP1 AFTER TESTING

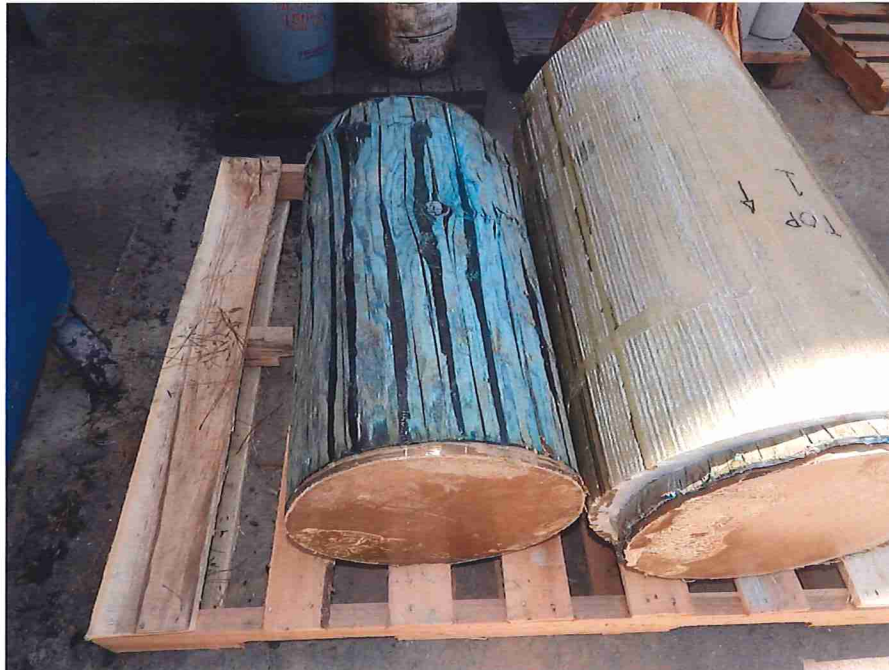
PHOTO No.8 CONTROL SAMPLE AFTER TESTING

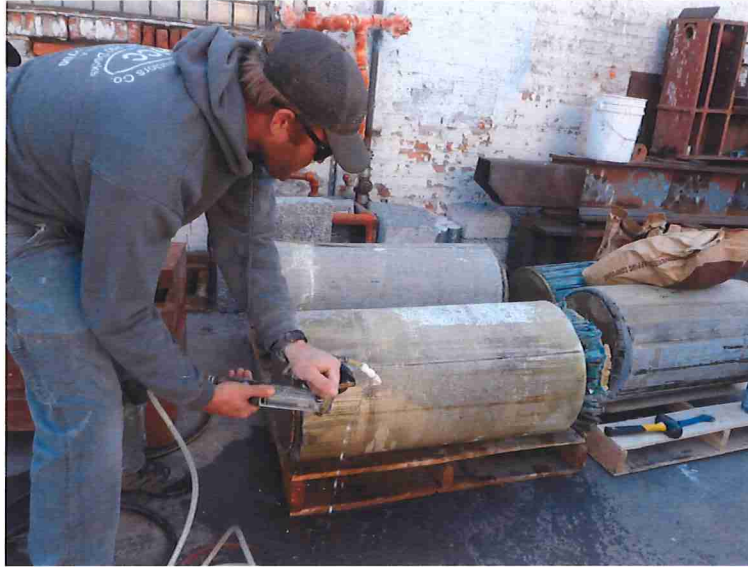
PHOTO No.9 OPENING SAMPLES BOT3 AND MID2

On samples BOT 3 and MID2 the GFRP Jacket and grout was removed on a portion of the sample to verify that the repaired section of the timber pile did not fail. See Pictures No. 9 through 13 for clarification.

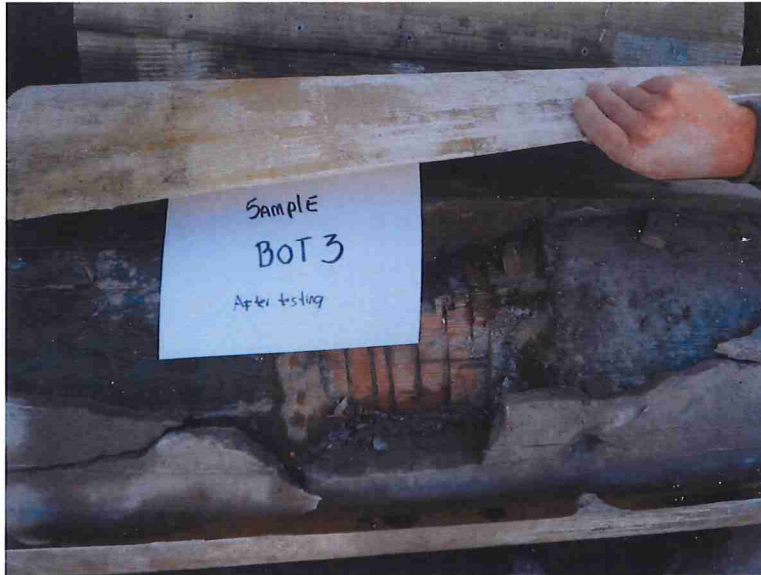
PHOTO No.10 EXPOSING PILE REPAIRED AREA, NO WOOD DAMAGE IN REPAIRED SECTION OF PILE WAS OBSERVED.

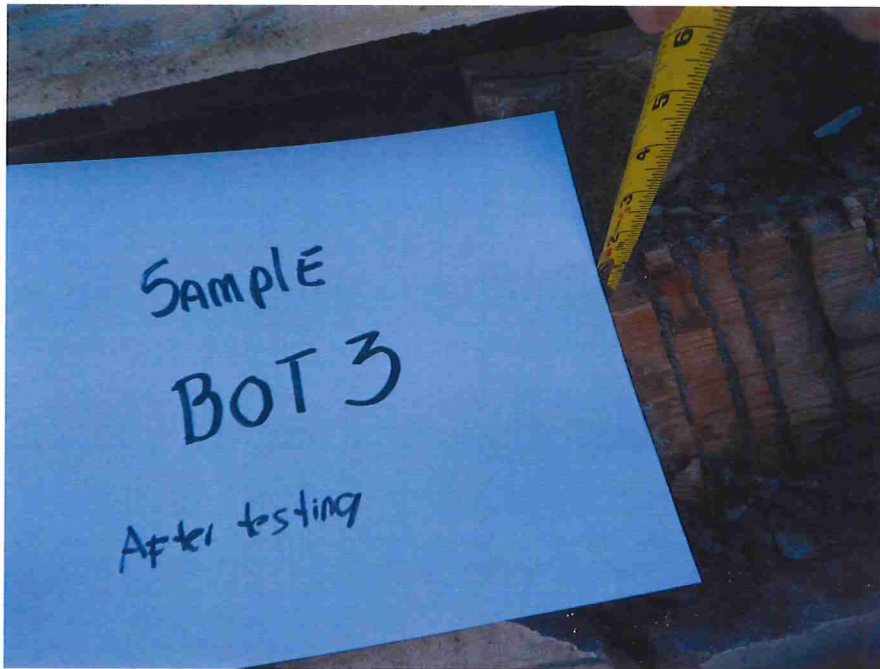
PHOTO NO.11 EXPOSING PILE REPAIRED AREA, NO WOOD DAMAGE IN REPAIRED SECTION OF PILE WAS OBSERVED.

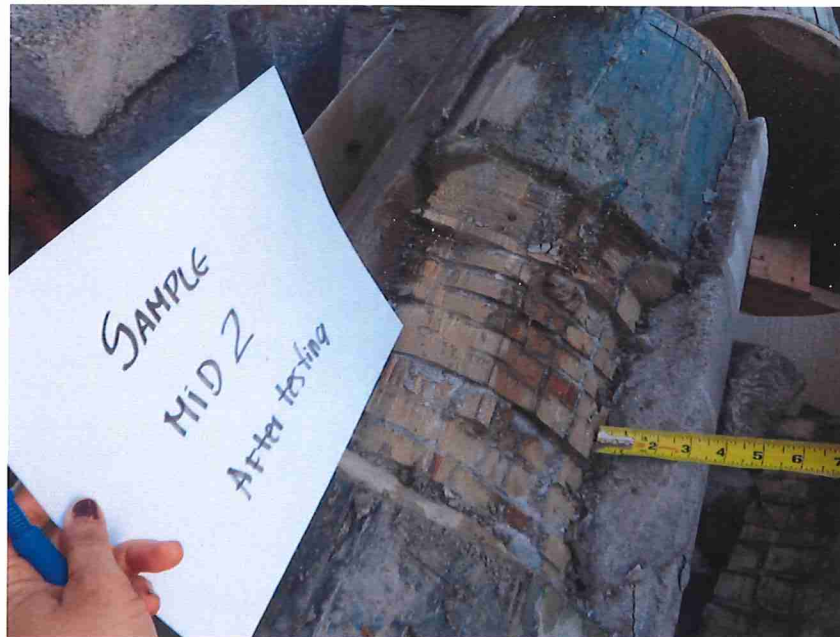
PHOTO NO.12 EXPOSING PILE REPAIRED AREA, NO WOOD DAMAGE IN REPAIRED SECTION OF PILE WAS OBSERVED

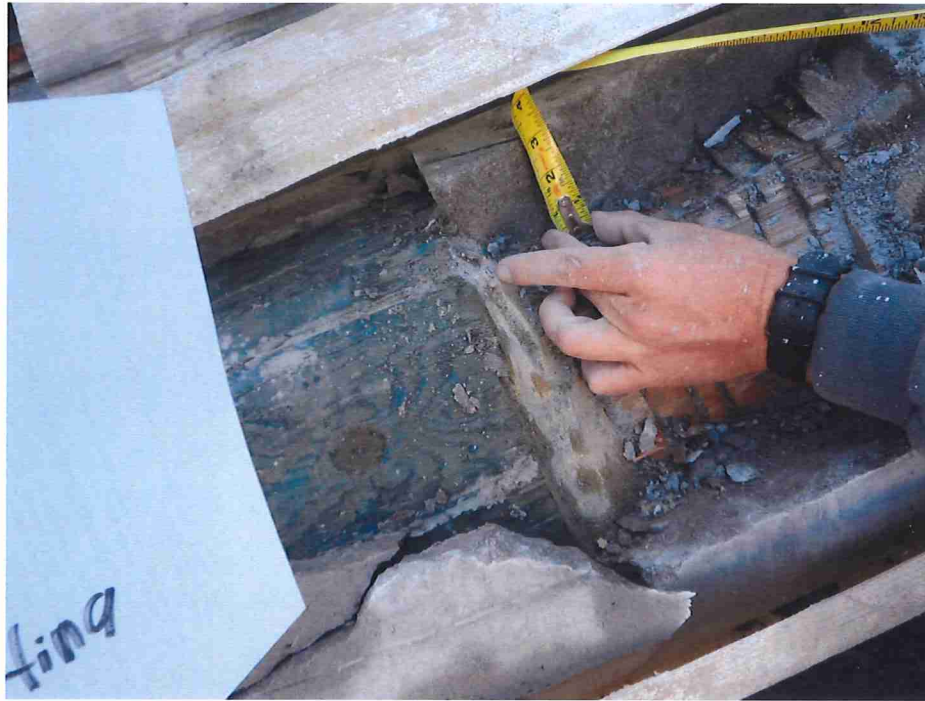
PHOTO NO.13 EXPOSING PILE REPAIRED AREA (MID 2 SAMPLE) , NO WOOD DAMAGE IN REPAIRED SECTION OF PILE WAS OBSERVED.
